Impact of Prolonged Exposure to Sour Service on the Mechanical Properties and Corrosion Mechanism of NACE Carbon Steel Material Used in Wet Sour Gas Multiphase Pipeline

Manoj Yadav ¹, Mostafa H. Sliem ², Aboubakr M. Abdullah ^{2,*}, Khaled M. Youssef ¹ and Noora H. Al-Qahtani ²

Abstract: The oil and gas industry is involved with severe corrosive/sour environmental conditions due to H₂S, CO₂, and moisture content. The National Association of Corrosion Engineers (NACE) has developed standards to enable users to select suitable materials for given sour conditions which utilize laboratory testing. A failed piping sample (API-5L-X65) was removed from a pipeline after 15 years of service. Optical microscopy was used to compare the microstructure of the corroded sample near the exposed surface to both the service environment, and further away from it. Moreover, pitted samples were analyzed using a scanning electron microscope coupled with energy dispersive X-ray (SEM/EDS) to understand the deposits' morphology. Furthermore, XPS analysis proves the presence of a significant content of sulfur compound. Additionally, the mechanical properties of both corroded and non-corroded samples were

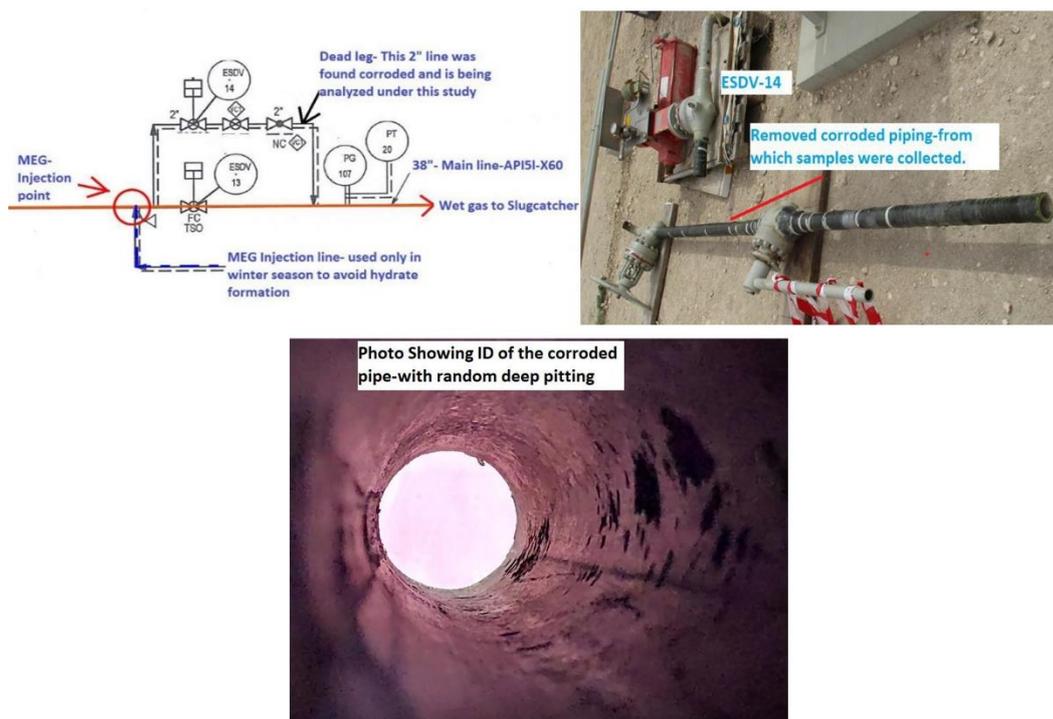
The corroded sample analyzed in this research is part of a wet gas inlet pipeline coming from offshore and going to the slug catcher. The corroded piping was a 2" bypass of an emergency shutdown valve (ESDV13) installed on a 38" mainline, as seen in Figure 1.

Figure 1. Showing the actual location of the corroded sample analyzed in this research and the inner diameter (ID) of the failed spool.

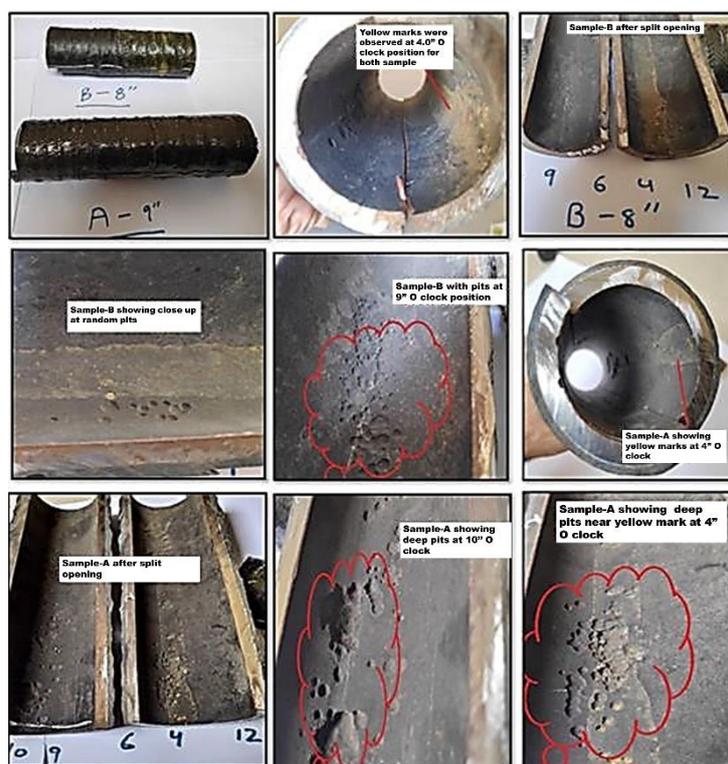
Figure 2 shows two pipe spools (A—9" and B—8") which were cut from the removed piping for investigation purposes. The bottom (six o'clock) position was marked in both spools. The corroded piping was externally composite-wrapped to avoid failure during operations. Composite wrapping is visible in the sample photographs. Close visual inspection was carried out on as-removed samples. Following are a few critical observations made on the collected samples: Both samples showed a band of yellow marking at the four o'clock position. Random pits were observed on both samples. The severity of pitting was at its maximum at the 9–10 o'clock position, near the yellow marking.

Figure 2. Visual observation graphs highlighting all critical points.

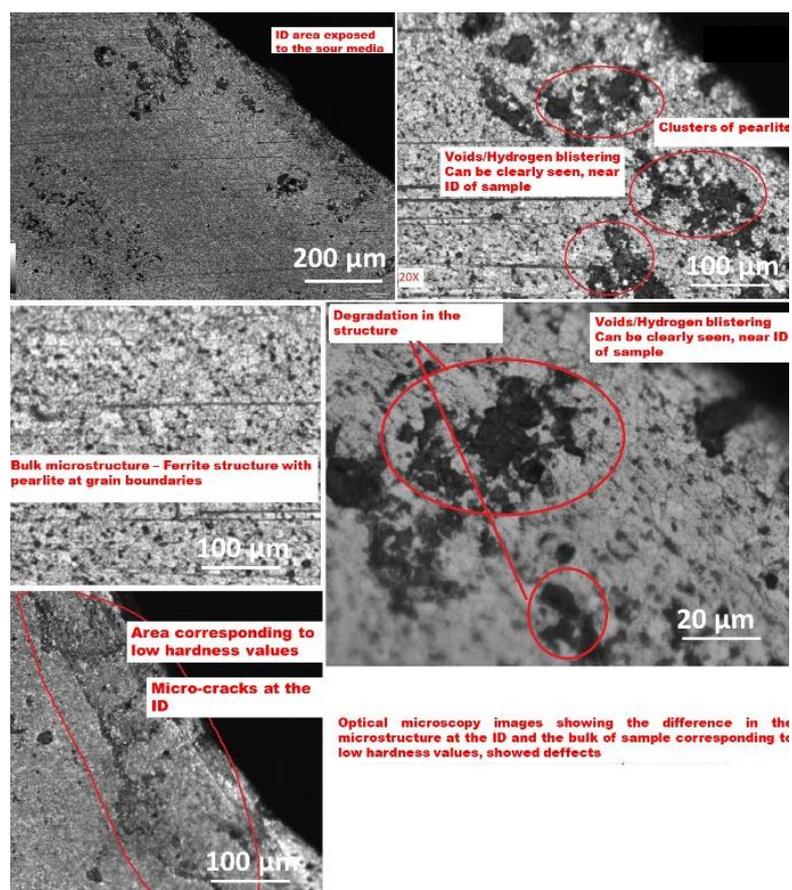
Different points in the defected surfaces were examined by optical microscopy to understand the difference in microstructure at the ID and bulk of the sample. Optical microscopy images, Figure 3, clearly indicate differences in microstructure in the area exposed to service (sample ID) and at the bulk of the samples. The cluster of hydrogen blisters can be seen near the ID of corroded samples. The area near the ID/corroded surface also corresponds to low hardness. The presence of micro-cracks near the ID of the sample is also clearly visible. These findings indicate significant degradation in the material due to long-term exposure to sour service.

Figure 3. Optical microscopy images at various mag, for both ID and bulk.

The SEM images of the pitted and not-pitted samples show a significant amount of porous deposits. Corrosion impacts the generation of atomic hydrogen, which can diffuse into steel and accumulate and form blisters, as seen in the optical microscopic images. The process parameters of the failed sample show the presence of sulfides, carbide, and free sulfur, thus making it a complex system to predict corrosion rates [33]. A lot of research has been undertaken to understand the effect of H_2S on the CO_2 system [34–39]. The corrosion process involves lots of complex combinations of reactions that affect the corrosion rates and film-forming rates. In the presence of aqueous H_2S , iron sulfide formation can take place by any of the three routes. First is the formation of the black layer by the anodic dissolution of iron at the surface. This FeS layer/film keeps on increasing by continuing the anodic dissolution of iron at the metal and sulfide film interface. However, the reaction rate is limited by the diffusion of Fe ions and electrons through the FeS layer. Another possibility is that Fe ions directly dissolve into the solution and react with sulfide ions present in the solution. No FeS layer is deposited on the solution/metal interface during this kind of interaction. Alternatively, ferrous ions can react at both the surface and the solution, resulting in the formation of a porous, non-adherent, and non-protective FeS layer. Besides enabling cathodic reactions, this corrosion layer also facilitates anodic dissolution of Fe which can be considered as a galvanic corrosion interaction [40,41]. As explained in XPS, elemental sulfur can further aggravate the corrosion rates. The above results indicate that the corrosion product layer observed in the examined samples is porous, non-adherent, and thus provides no protection against ongoing corrosion.

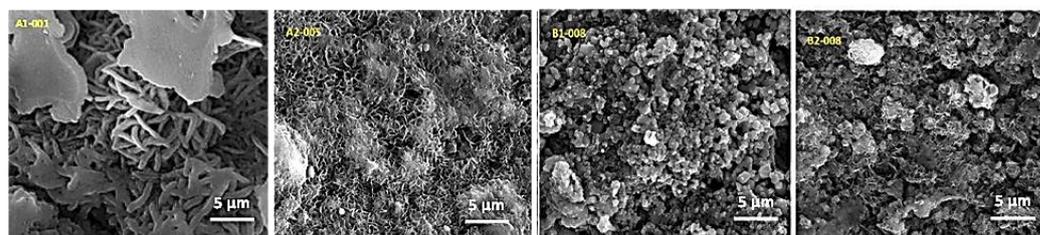
Figure 4 depicts the SEM images of samples with pitting in the yellow-mark area represented in points A1, A2, B1, and B2. All points prove the porous nature of corrosion scales; furthermore, in the close-up view of the scales in B1 and B2, the aggregated particles confirm the presence of sulfur.

Figure 4. SEM micrographs samples with pitting inside yellow-mark area (A1, A2, B1, B2).

Carbon, iron, elemental sulfur, sodium, and potassium were found in all EDS analyses. The corrosion deposit layer was found porous (non-adherent) with multiple cracks, which indicates active corrosion. Samples with visible pits were also seen with corrosion products, similar to the one found in the pitted samples. The SEM images clearly indicate active corrosion happening in the piping.

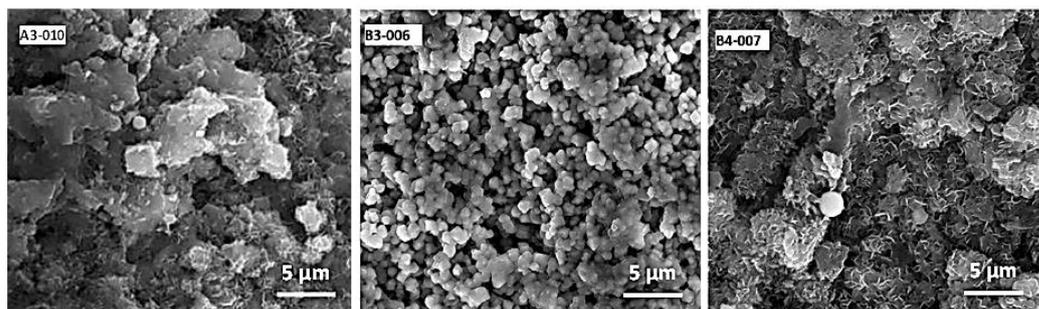
Figure 5 shows the SEM images of the samples with pitting corrosion outside the yellow-mark area: A3, B3, and B4. The SEM images are evidence of the sulfur grains of these samples.

Figure 5. SEM analysis for samples with pitting outside the yellow-mark area (A3, B3, B4).

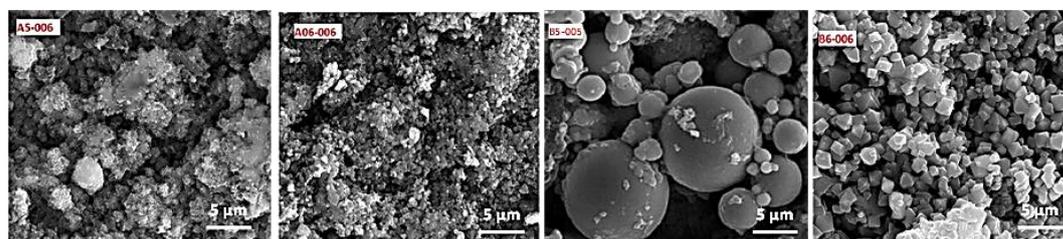
Figure 6 represents the SEM images of the samples with no evident pitting corrosion (A5, A6, B5, B6). It can be noticed that the SEM image of point B5 shows a spherical mineral aggregate. Meanwhile, the caption of the B6 image shows possible sulfur grains.

Figure 6. SEM analysis for samples without pitting (A5, A6, B5, B6).

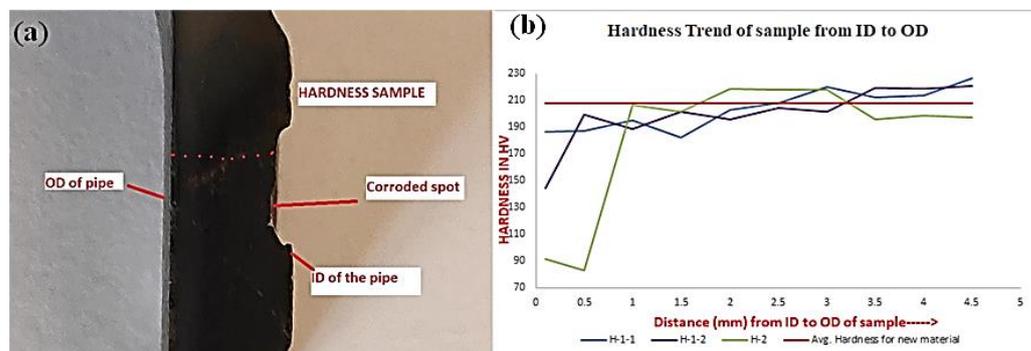
As mentioned previously, two corroded samples were polished, and microhardness was taken across the cross-sectional area to understand the difference in hardness from the ID to the OD of the samples. Figure 7 shows one of the samples, and the hardness profile was developed from the ID to the OD, i.e., from the corroded surface to the bulk material.

Figure 7. (a) Image for one of the tested samples and (b) Hardness results of the samples.

The low thickness is evident at the ID (near the corroded surface) of the samples. Hardness in the bulk material (at center and OD) is observed to be similar to the average hardness of the new API 5L-X60 material. Loss of hardness is aligned with yield strength,

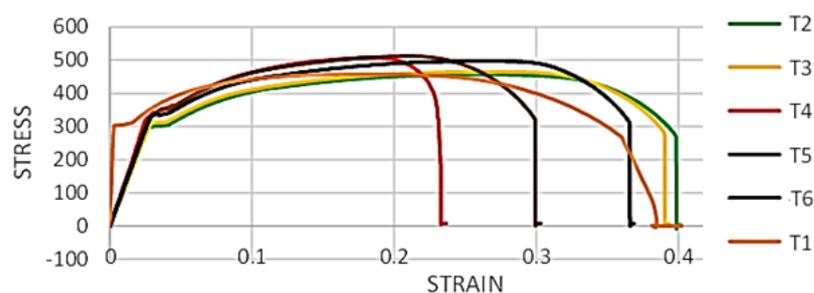
Figure 8 shows the elongated length of all failed samples. It is evident that the elongated length of corroded samples (T4, T5, and T6) is lesser than the elongated length of un-corroded samples (T1, T2, and T3). The difference in the elastic modulus of stress-strain curves is due to the resistance of the sample to elastic deformation; hence, the samples with higher elastic modulus are harder than samples with a lower elongated length. Based on the observed results, the area under the stress strain curve clearly shows a reduction in the toughness of the corroded samples. The loss in yield and tensile strength is evident in all samples (corroded or non-corroded). In wet H₂S environments, the H⁺ ions combine with the electron released by the corrosion of piping, and from atomic hydrogen. More active corrosion yields more atomic hydrogen on the piping surface exposed to the sour service. Atomic hydrogen can recombine to form molecular hydrogen, which is usually harmless for steel. However, this atomic hydrogen recombination reaction rate is significantly reduced due to the presence of H₂S. Thus, the accumulated atomic hydrogen on the steel surface can permeate into the steel material and accumulates at available hydrogen traps (inclusions/grain boundaries/laminations/dislocations, etc.). This permeation of atomic hydrogen is directly proportional to the partial pressure of H₂S in the service [16,17].

Figure 8. Stress – strain graphs of all tensile samples.

The samples tested during this research were operated at 80 bar pressure, with 3 mol% of H₂S in the liquid phase. This accumulated hydrogen can promote dislocation emission, multiplication, and motion at the local hydrogen enrichment region [15,18]. Another effect of hydrogen is to decrease the cohesive strength of Fe-Fe bonds. Finally, yet importantly, accumulated atomic hydrogen can recombine and form molecular H₂, thus increasing the internal pressure, enhancing the crack growth and the reduction in both yield and tensile strength [12]. Another important observation made from the tensile testing is that the corroded samples showed relatively lesser % elongation when compared to non-corroded samples. Corroded samples were not polished and had noticeable pits at the center of the reduced cross-sectional area of the tensile samples. Pitting corrosion can act as a stress concentration site and thus can affect the overall elongation of the corroded samples though overall, all samples revealed higher % elongation than the minimum required (17.5%) as per standard. The other main reason for this relatively lower elongation % in the corroded samples could be bulk material degradation (both macroscopic and microscopic) due to the combination of the effect of stresses and a corrosive environment [11]. The charged hydrogen can significantly increase the dislocation density, increasing the strength and reducing the % elongation in corroded samples compared with non-corroded samples.

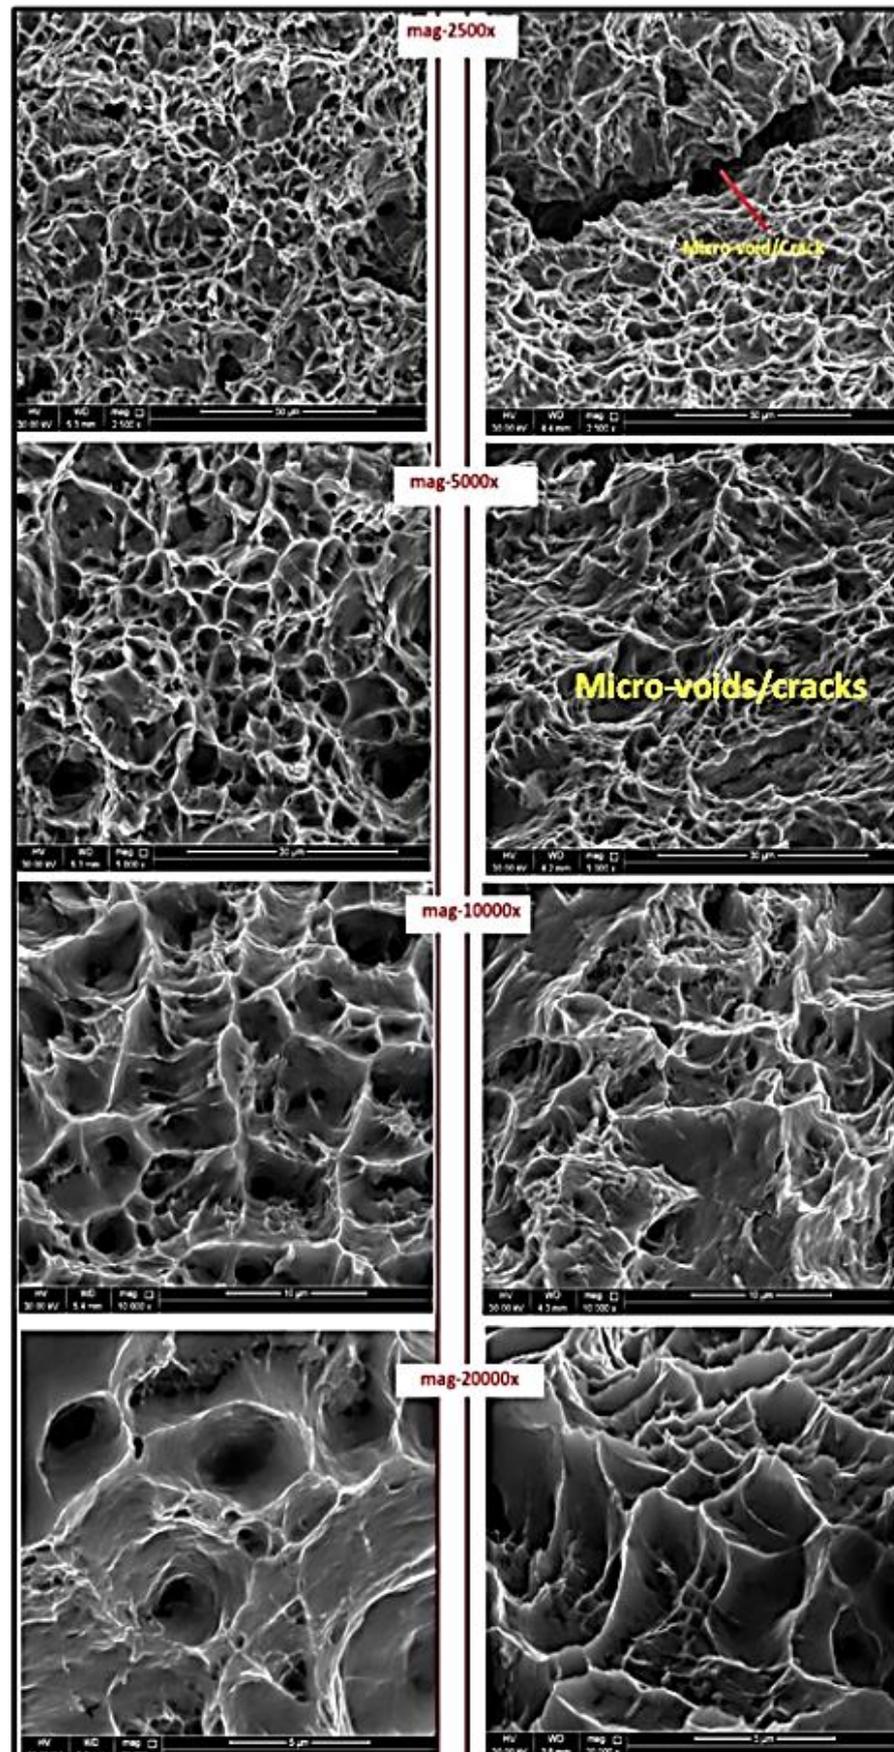
Two fractured surfaces from the tensile test for corroded and non-corroded samples were analyzed with SEM to understand the difference in the failure mode of corroded and non-corroded samples, which are represented by T2 and T4, respectively. Figure 9 shows the SEM images at different magnifications of both samples. Significant differences can be noticed in the failed tips. Micro-voids or cracks can be seen in sample T2. The depth of the cup/cone is significantly more in the T4 sample. Thus, indicating that active corrosion impacts the ductility and microstructure of the piping material. The same was noticed in terms of the elongation% results.

Figure 9. SEM images for failed T2 (Left) and T4 (Right) tensile samples.

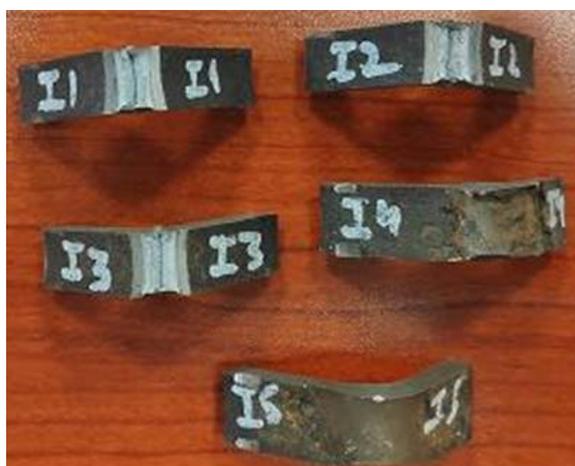
Figure 10 illustrates the broken impact samples. It is evident that the samples without a notch did not break and absorbed more energy. Additionally, the notched samples were not broken into two pieces. However, as per the ASTM standard-E23: If a fractured impact specimen does not separate into two pieces, report it as unbroken. Unbroken specimens with absorbed energies of less than 80% of the machine capacity may be averaged out with the values from broken specimens [14].

Figure 10. Charpy specimens after the test.

A significant decrease in brittle fracture resistance (absorbed energy) at room temperature was noticed in all tested samples. This may be explained by the presence of hydrogen (produced due to corrosion) mostly bound in deep traps and inclusion sites available in the original material. During the impact tests, the diffusion and accumulation of hydrogen were inhibited due to the high-impact speed. The reduction in the Charpy absorbed energy of specimens after corrosion is mainly attributed to the decreasing Fe-Fe bonds and the presence of hydrogen-induced microcracks [20]. Similar results were also reported by researchers while testing an in-service material X52 Steel [11].

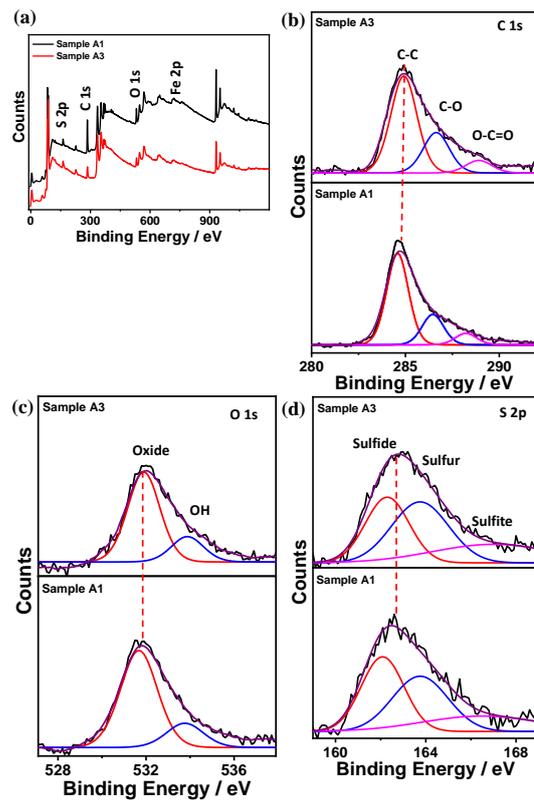
The peak fitting of XPS data shows the presence of hydrocarbon, iron oxides, iron sulfide, iron sulfite, and elemental sulfur. The presence of elemental sulfur explains the yellow layer observed in the corroded samples during visual inspection. Glycol was injected into the piping during every winter season to inhibit hydrate formation, which explains the presence of hydroxide in deposits. The presence of elemental sulfur in a sour environment makes it very aggressive for corrosion [19]. Elemental sulfur is generally present in the sour gas coming from offshore and is produced due to oxidation of H₂S. Like the temperature, the pressure of the pipeline changes, and the elemental sulfur can accumulate on the pipe surface and cause a catastrophic corrosion of carbon steel [21]. The corroded pipe taken for this research is a dead-leg (a portion of pipe with no flow/intermittent flow), and thus conditions are ideal for the elemental sulfur deposition. Formation of elemental sulfur can take place in an aqueous system as a result of the oxidation of sulfide species, as shown by the following equations [22]:

Figure 11. XPS spectrum for samples A1/A3 (a) full survey, (b) carbon, (c) oxygen, and (d) sulfur.

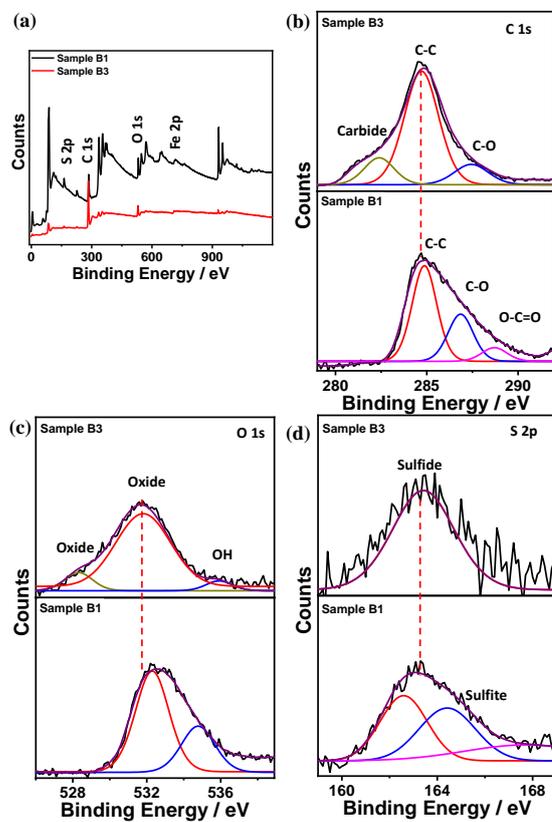
Figure 12. XPS spectrum for samples B1/B3 (a) full survey, (b) carbon, (c) oxygen, and (d) sulfur.

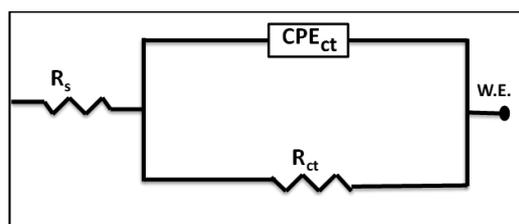
An EIS technique was employed to describe the electrode/electrolyte interfaces quantitatively. It is considered a potent method that can explain the corrosion behavior and calculate their rates [27–32]. Figure 13 shows the proposed equivalent circuit (EC) utilized to analyze and fit the collected experimental data. It exhibits the one-time constant equivalent circuit. The parameters of the electrochemical reactions occurring at the metal/solution interface are listed in Table 7, and are measured and calculated from the EIS Nyquist plot, in which the electrolyte resistance (R_s), charge transfer resistance (R_{ct}), constant phase elements for the charge transfer resistance (CPE_{ct}), and the deviation parameters (n) from the ideal double-layer capacitance (C_{dl}) are included.

Figure 13. An equivalent circuit (EC) was used to fit the measured data.

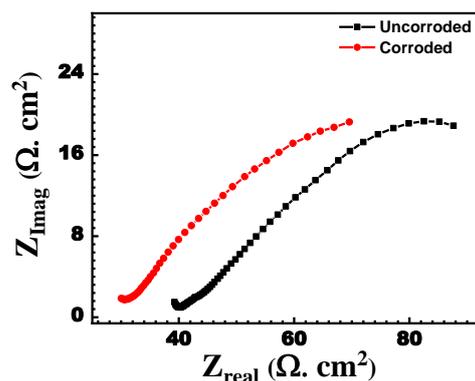
Figure 14 shows the measured Nyquist EIS data for uncorroded and corroded API-5L-X60 specimens immersed in 0.5 M Na_2SO_4 to compare the corrosion behavior of the two specimens. Table 7 clearly shows that the corroded sample (without polishing) exhibits a lower corrosion resistance when compared to the un-corroded polished sample. This also proves that the corrosion product layer on the corroded sample does not adhere and is not sufficient to stop further corrosion. These results are also aligned with the SEM images, which showed the porosity in the corrosion deposits found in the samples.

Figure 14. Nyquist plots for the measured EIS data (dots) for non-corroded (black) and corroded (red) API-5L-X60 specimens immersed in 0.5 M Na_2SO_4 . The solid lines are the fitted curves.
